SOIL STABILIZATION USING HYDRATED LIME & GEOSYNTHETIC AT PT. ASTRA HONDA MOTOR PQE FACILITIES

PT. CONBLOC INFRATECNO

OVERVIEW

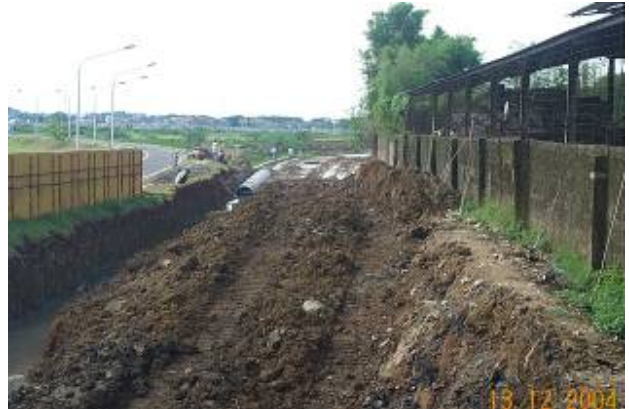
Existing Condition of the Access Road

The existing poor soil condition was a challenge to Conbloc's engineers to find out the best possible solution to improve its characteristics. The existing soil mostly consists of **EXPANSIVE CLAY** which has very poor bearing capability ($\text{CBR} < 1\%$) and has **HIGH SWELLING POTENTIAL** ($\text{PI} > 20$).

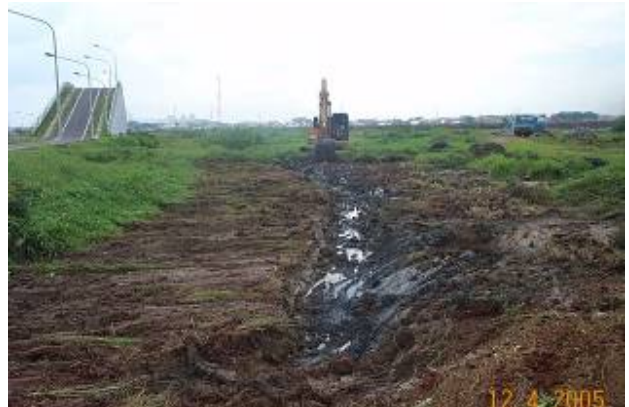
Existing Condition of the Inspection Road

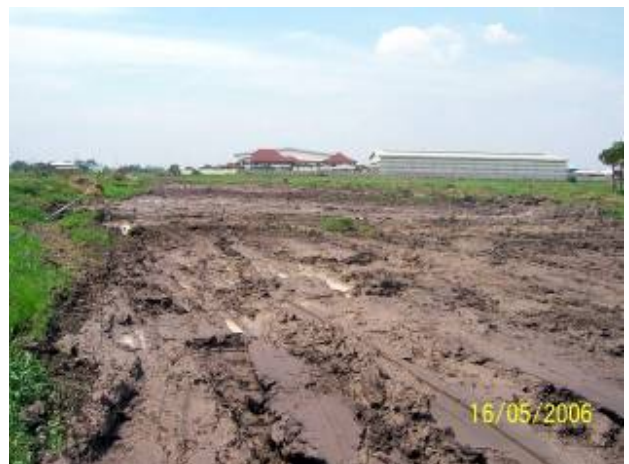
Existing Condition of the 2nd Stage Test Course

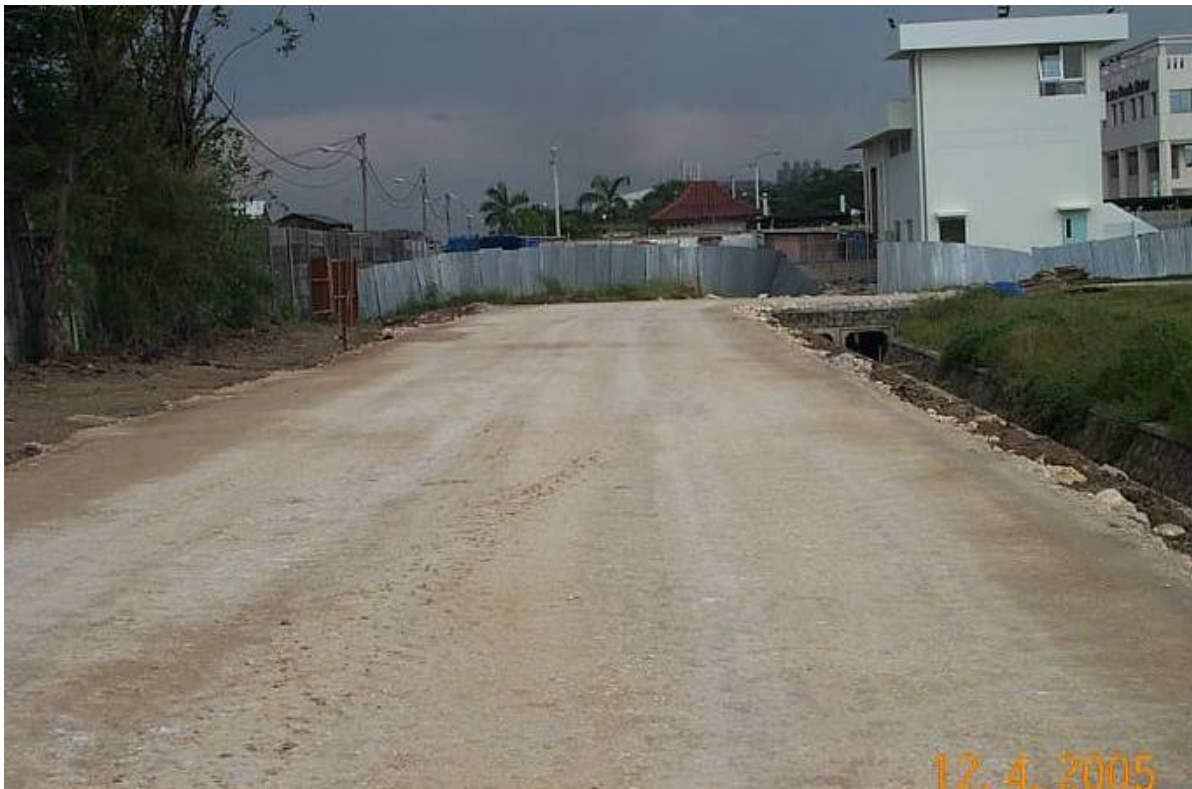
Pavement Structure Strengthening using Modified Cement Treated Base

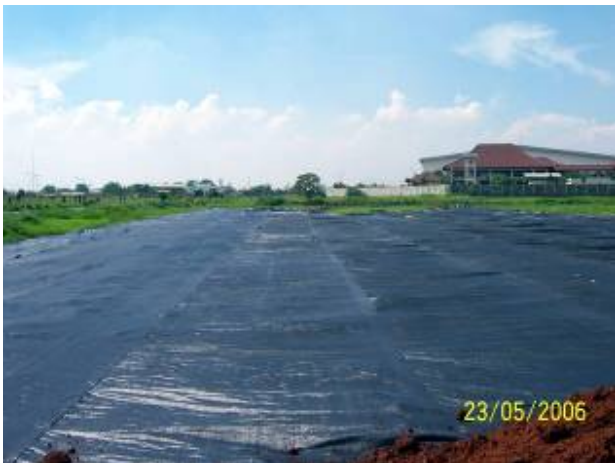
*Soil Stabilization using geosynthetic
2nd Stage Test Course*

Second, using geosynthetic material. This method facilitates to improve the shear strength of material. This method was used to build the 2nd stage test course.

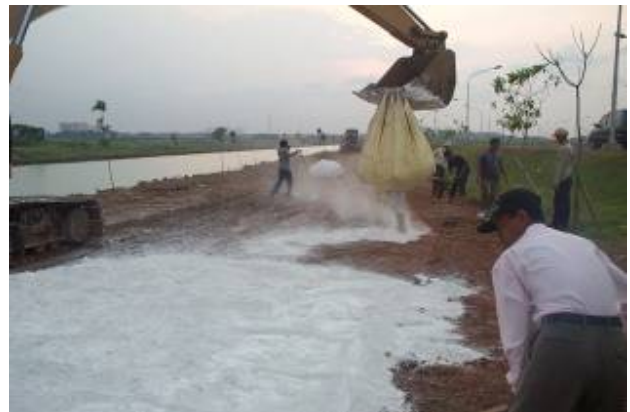
Hydrated Lime spreading

3% by weight of hydrated lime was spread on top of existing soil.

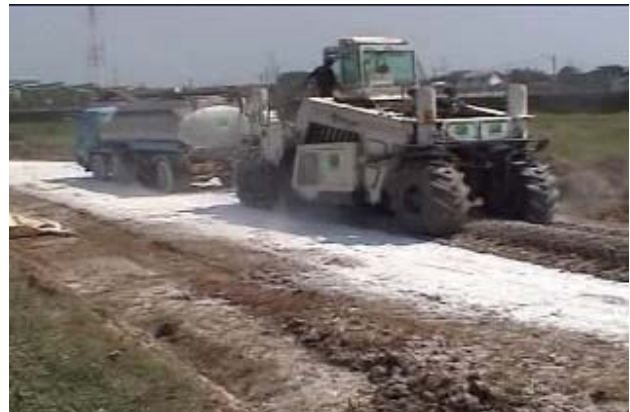
Soil stabilization using Hydrated Lime connected to a Water Tank

Soil and the spread Hydrated Lime were mixed by Recycler/Stabilizer machine which was connected to a water tank to add sufficient water to allow the stabilized soil can be compacted well.

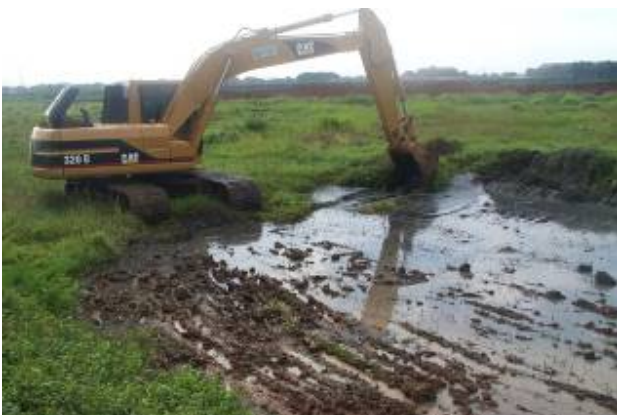
Dewatering & Land Preparation

The existing soil water was drained out to reduce its moisture content. Temporary ditch was built using heavy equipment. The vegetation was scrapped to remove the organic materials.

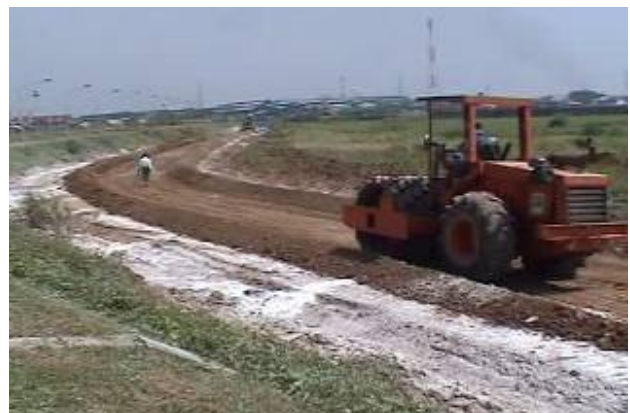
Trimming and Compaction

After 48 hours, the stabilized soil can be trimmed and compacted. The road base was built over the stabilized soil.

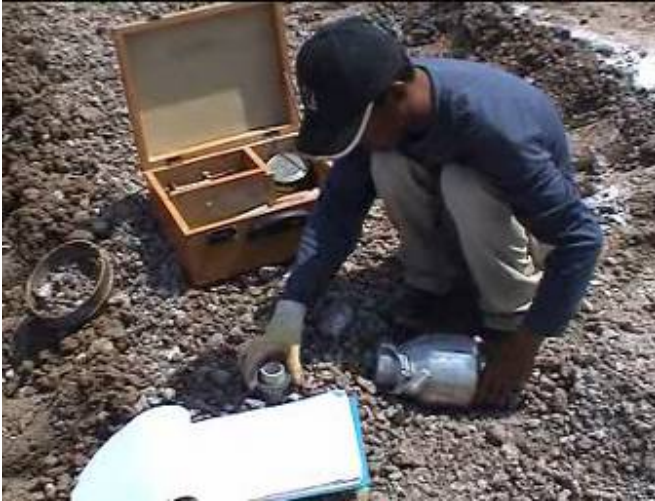
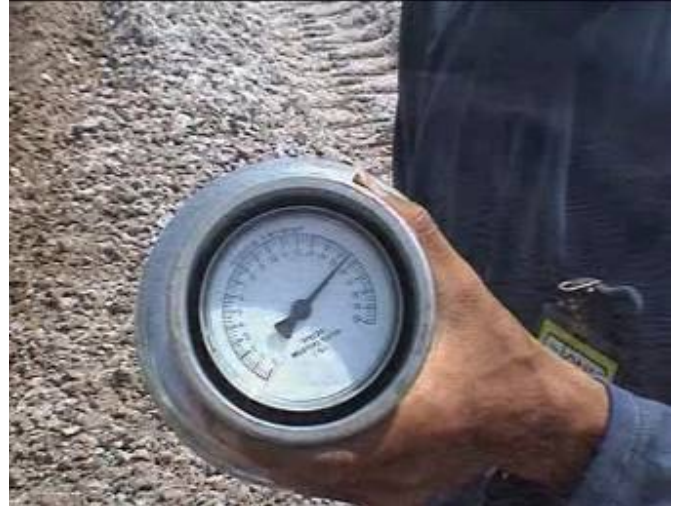
Moisture Content Test Using Speedy Tester

Quality control tests conducted during and after construction, showing satisfactory results of the stabilized soil performance. Hydrated lime stabilization on this type of soil has resulted in higher bearing capacity (CBR) and lowered the swelling potential as well (PI).

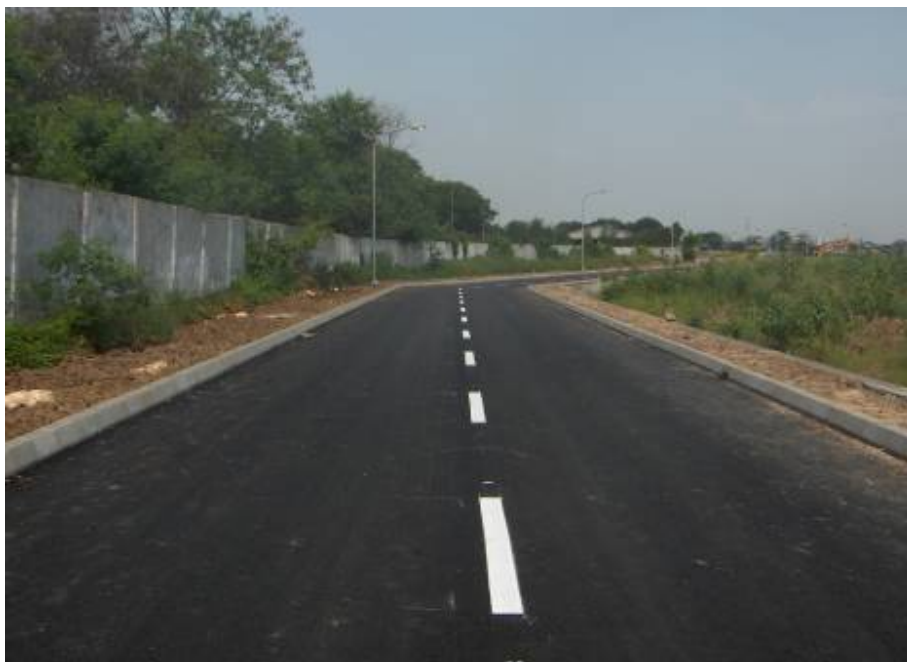
Access Road – After one year of maintenance period
